# JARDINS DE PIERRES

***14<sup>es</sup> journées d'étude de la SFIC***  
***PARIS, Institut national du patrimoine, 22-24 juin 2011***

# STUDY-CONSERVATION-RESTORATION OF SCULPTURES & SURROUNDING IN A CENTRAL PARK OF ATHENS

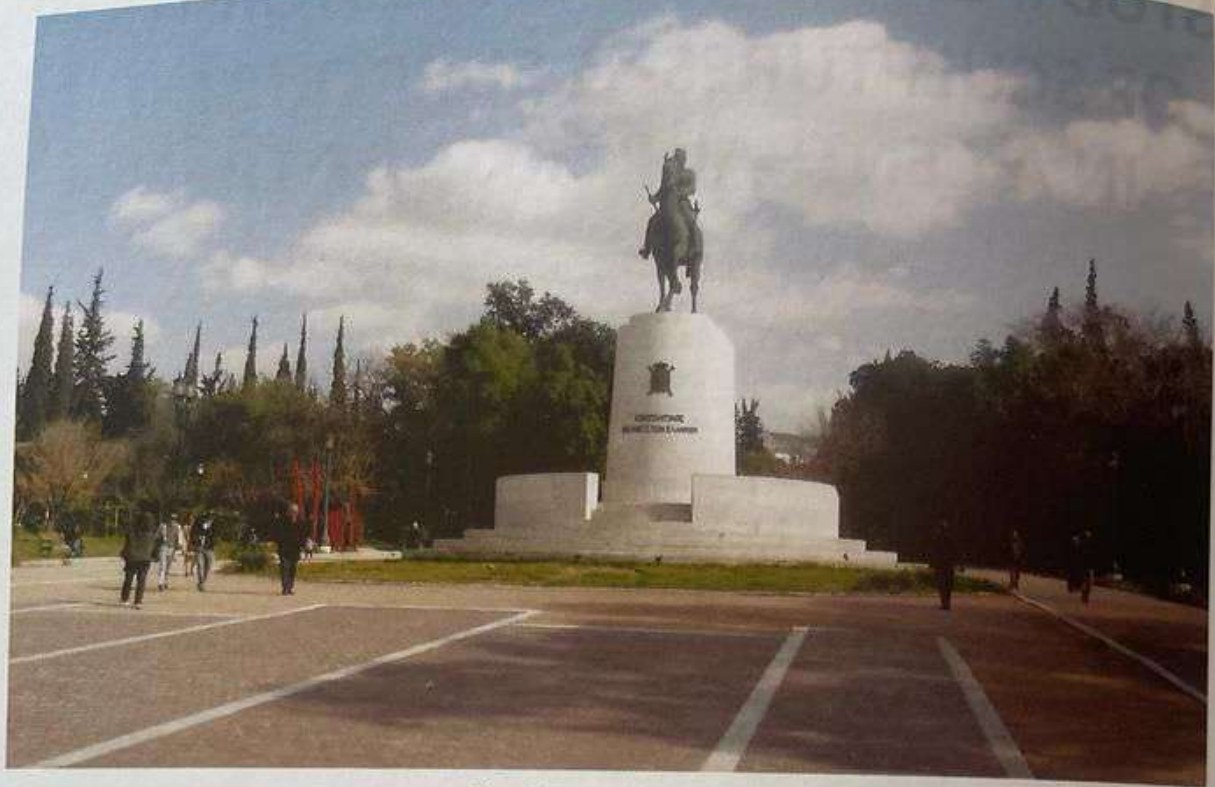
Fig. 1. View of the park.

placed in Panepistimiou street and then in the park in 1885. The park contains fountains, playgrounds, walking paths, water course and rich vegetation, high and low, which is in direct contact with the monuments. These features of the park in conjunction with the weather conditions, the polluted air and the human element have been a multifaceted challenge (fig. 1).

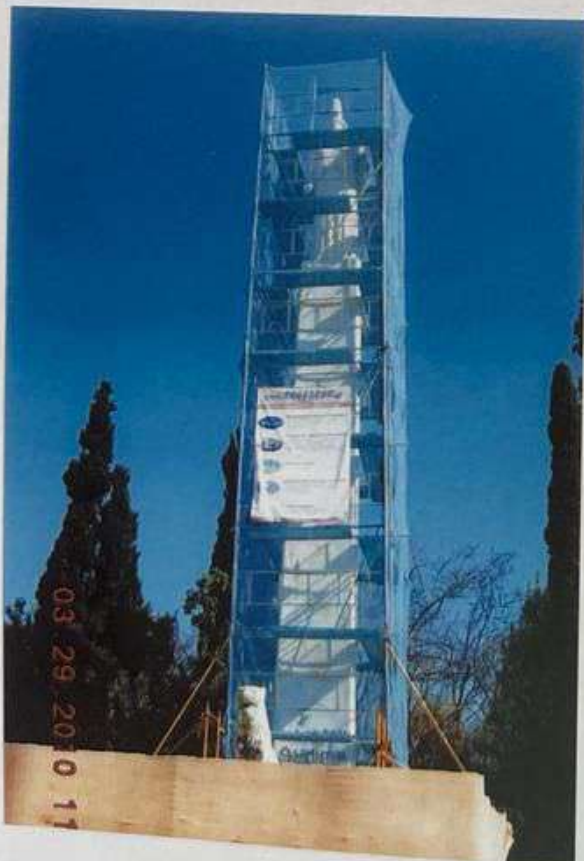
Fig. 2. The configuring of our workplace in the statue of Goddess Athena and the Burial monuments of the fighters from New Zealand, Australia and England at the Second War (photos from the Archive of Constance Kokotou, during the conservation of monuments, 2010).

of working around each monument. So, we decided to install a constant, mobile scaffolding with canvas around it, which was constituted by wooden floors and ladders according to the height of each monument (fig.. 2). The vegetation was neglected and in direct contact with the monuments and humidity everywhere around them due to muddy and stagnant waters. All the monuments were preserved in situ. There was only a thought of transferring to a museum Alexander Ypsilanti's statue due to its strongly corrosion/decay. Its replacement with a replica is not an easy decision to be taken immediately. The monuments are not preferable to be moved out from the park as they contribute to its Historical character too.

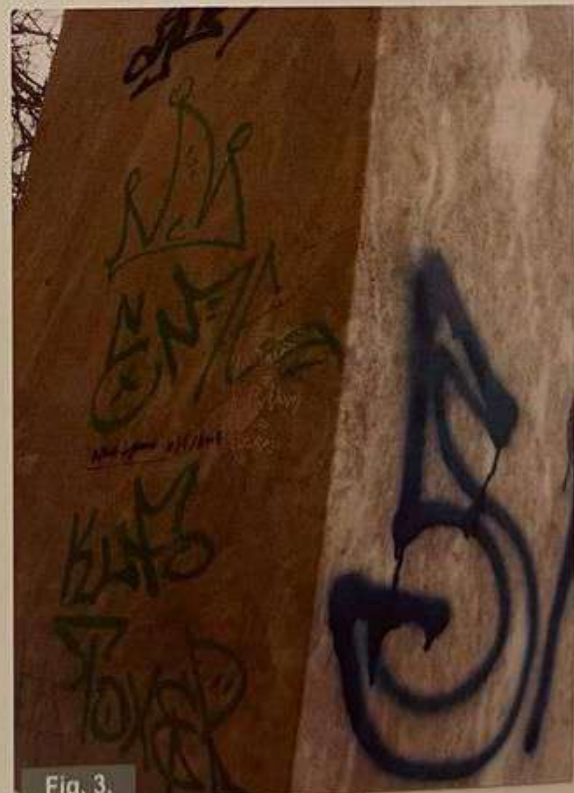
days. The graffiti were located mostly to the rear sides of the monuments (columns) and bases (fig. 3). Most of the markers/crayons contained iron (Fe). Before apply anything to remove them, we used sponge with deionized water to soften the painted surface. Each application which differed from place to place, needed some time to react, so we used sheets of polyethylene to cover the spots and accelerate the procedure. Some felt-tip pen were removed with cotton or carboxymethylcellulose with acetone and white spirit ( $C_9H_{20}$ ), slow scrubbing with soft brush. Graffiti were removed with a sepiolite (absorbent clay in deionized water) paste with Japanese paper. Also some test done with White Spirit and softly scrubbing with soft brushes. The stains from soils generated by the graffiti removal were removed with a paste made of 20 g wax, 100 g paraffin wax, 100 ml acetone, 80 ml of soluble ammonia ( $NH_3$ ) 25 % and 50 ml white spirit. In all cases the method was monitored during the implementation in order to avoid the creation of further stains, it was applied with small brush and the rinsing was necessarily done with deionized water.

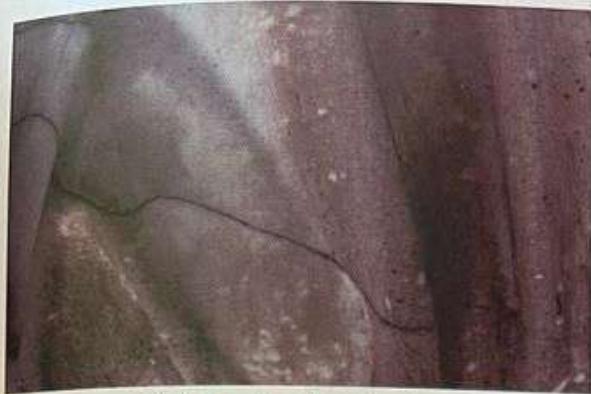
Fig. 4. Marble aftercleaning.

Bacteria, algae, moss, lichens, microorganisms, birds, insects and plants were badly affected the monuments, either superficially leaving the marble embossed and inside its structure, causing cracks networks and moisture retention. To face this, we associated chemical treatment with mechanical cleaning (fig. 4).

First we applied absorbent clay impregnated with a biocide (Desogen, Ciba Geigy). The virtue of this method is its stability, the long period of reaction and possibility to perform several applications, without affecting negatively the marble. We also used Lito 7 and Lito 3 (Ciba Geigy) which were more active on microorganisms. We observed that in areas where paste with EDTA was placed and then Desogen biocide was used for microorganisms nearby, the biocide was really effective. After these treatments, the marble surface was rinsed with deionized water. To clean the cracks, hydrogen peroxide ( $H_2O_2$ ) 10 % max. appeared to be suitable. It was applied with syringe and needle in order to remove completely the lichens and their colouring agents. In this phase of the conservation process, we also used soft toothbrushes and various dental tools. Temperature fluctuations (sun in the morning and cold at night) also affected the inner structure of historic marble and cause mechanical decay. The marble monuments were to a great extent stained by iron oxides origina-

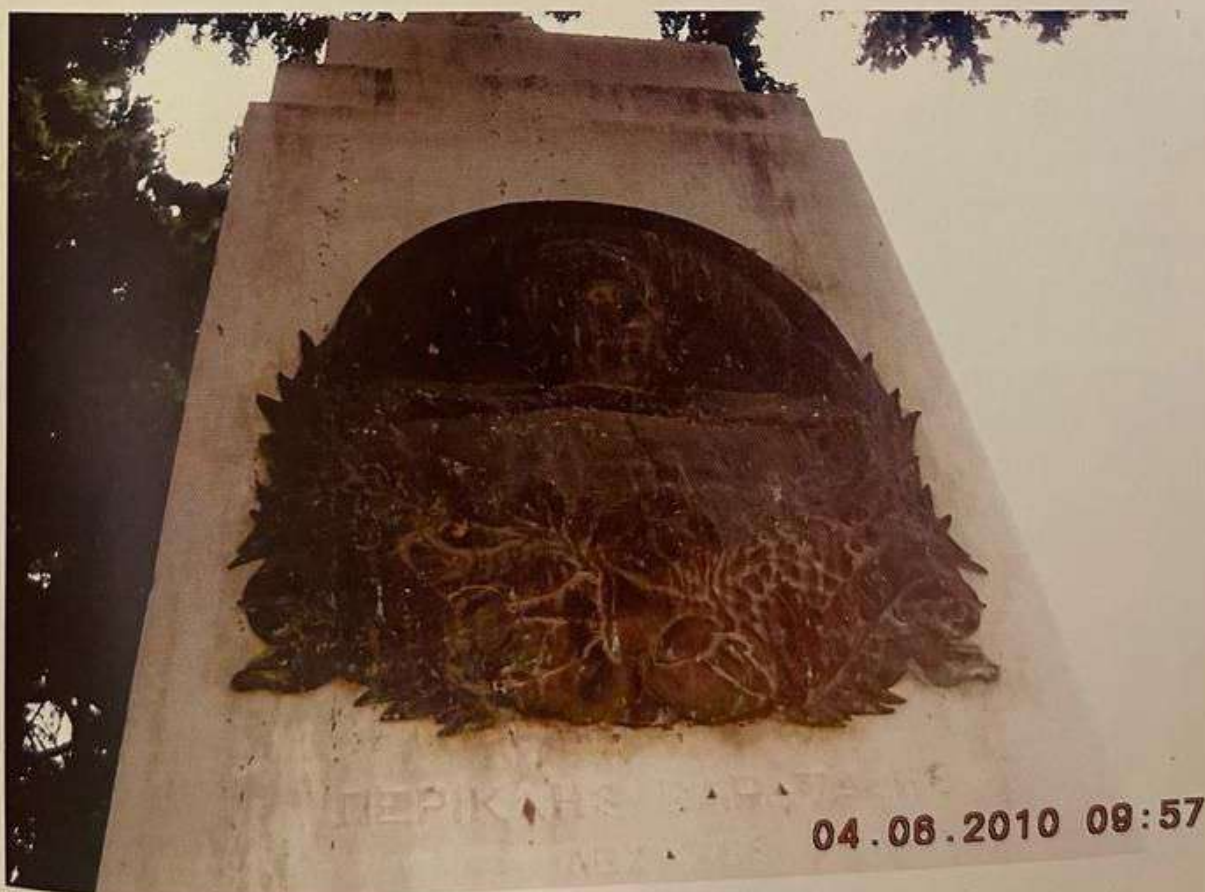
Fig. 5. Bronze inserts elements.

Along with the preservation of the Historic marble, **the bronze inserts** elements were preserved too (fig. 5). All of them are made from **copper alloy (bronze)**, so the corrosion products were many, as oxides, carbonates, chlorides, sulphates, etc. The most appropriate analysis to locate them would have been radiography. But due to position and size of monuments, this was unfeasible. We took samples from the bronze inserts that we found (many of them had been stolen or had disappeared) for analysis by Scanning Electron Microscopy with energy dispersive spectrometry and optical microscopy.

acids such as formic acid (HCOOH, Abio, Athens) 5 % w/v and Citric acid (C<sub>6</sub>H<sub>8</sub>O<sub>7</sub>). The surface was then rinsed off with deionized water at the temperature of the environment (luckily warm those days) and before starting we covered the marbles with canvas and plastic sheets to avoid further contact.

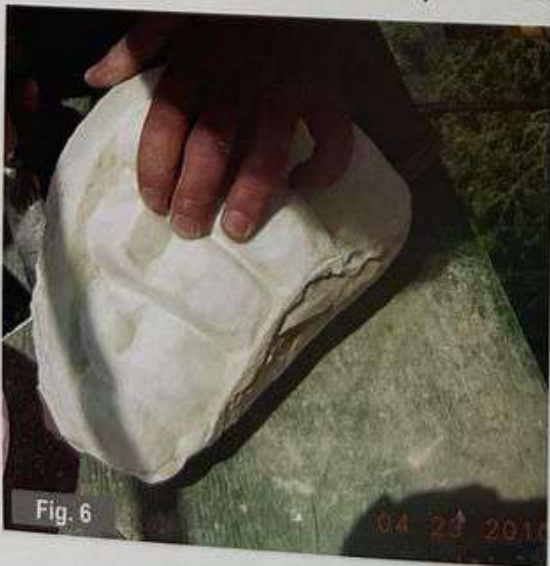
Fig. 6

Grouts consist are meant to fill up microcracks, either deep or shallow. Two mortars types were used: fine and coarse. The mortar usually covers the grout, fills up the bigger voids and connects missing/broken parts of the monuments (e.x. the leg of goddess Athena, fig. 6). The role of both of them (grout-mortar) is adhesive, covering and protective at the same time for the marble. They do not contain soluble salts, and they have great resistance to mechanical stresses.

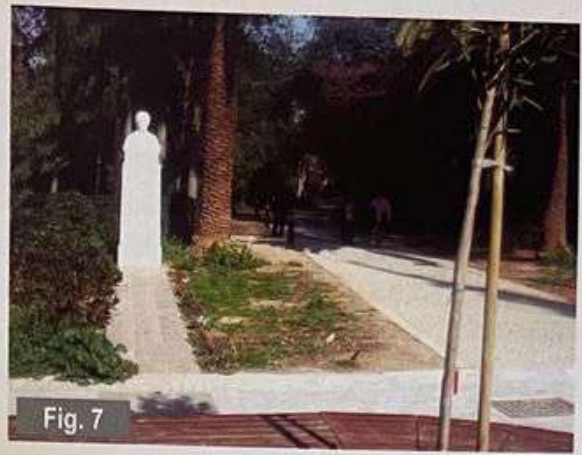
The final protection/fixation was achieved with lime water, which consists in of

calcium hydroxide  $[Ca(OH)_2]$  dissolved in deionized water. It is specially used in monuments in the centre of cities and is chemically related to limestone. The monument is first sprayed with deionized water and then with lime water. To be successful, the treatment has to be repeated many times, the number of treatments being adapted to the needs of each monument<sup>4</sup>.

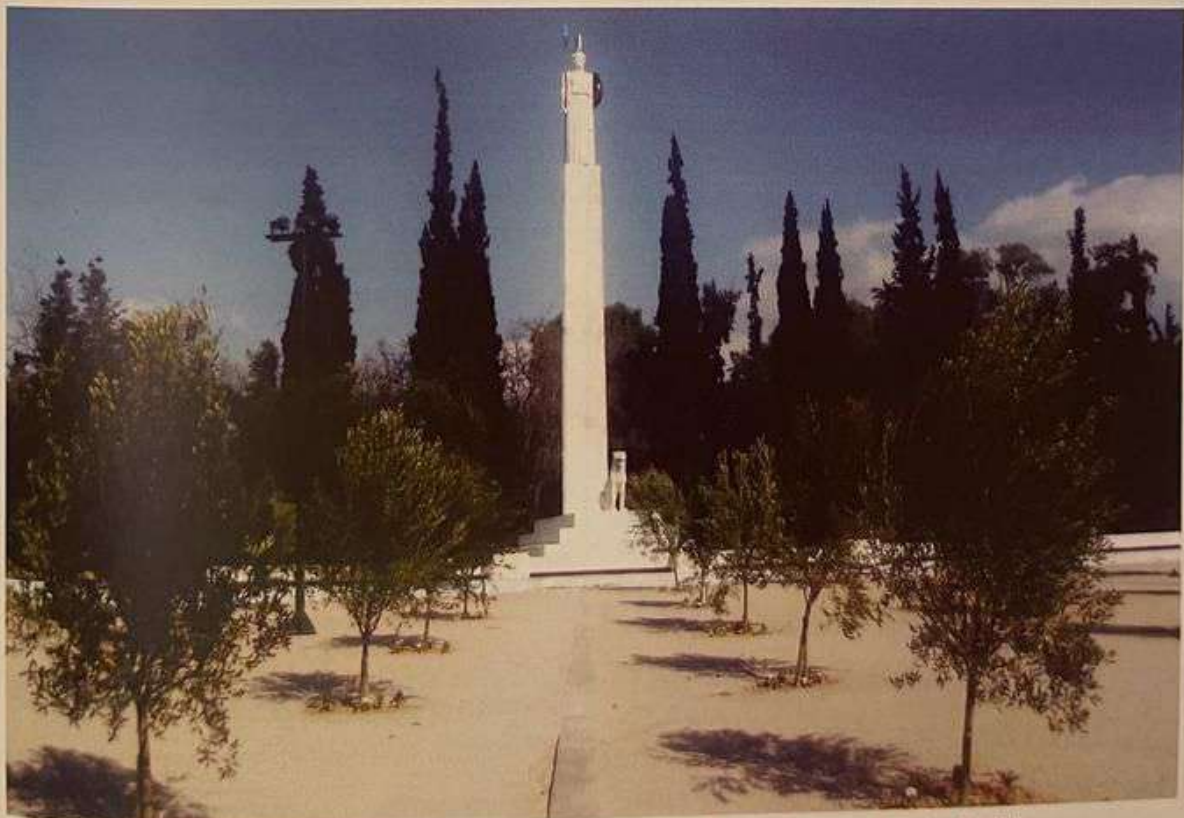
Fig. 8. The final appearance of the statue of Athena Goddess, Lion and the Burials, after the conservation of Monuments and the regeneration of the environment (photos from the Archive of Constance Kokotou, after the restoration of the park, 2011).

The monuments stand now in harmony with their **environment** and each part of the Park - tiling, benches, new fountains - has an extraordinary aesthetical value. The statues, the busts, the funerary monuments, the commemorative and dedicatory columns, are situated in locations that do not induce degradation anymore, but highlights them, and contributes to identify each character of the monument (fig. 7). For example, the funerary monuments of Australians in front of goddess Athena and Lion are highlighted by small olive trees—symbol of eternity for Greece (fig. 8). A great achievement is the fact that now all the visitors pay attention to monuments. Not only they realize their existence, but also understand their role and character. They can be informed about the monuments, they can realize the urban fabric of the park and be happy with nature. Generally, the plants have no contact with the monuments but emphasize with their shape and healthy image the role and purpose of sculptures in the park. All the paths and routes have been replaced with ecological materials and joints were created at both sides of each route in order to run off the rain water. An islet was constructed in the "Road of Heroes" full of flowers and wooden benches around it, in order to give the opportunity to visitors of the Park to admire the busts and the nature at the same time. The fountains have been replaced either by new ones that
